U.S. Department
of Transportation
**Urban Mass
Transportation
Administration**

Evacuation and Rescue of Elderly and Disabled Passengers from Paratransit Vans and Buses

October 1984
Final Report

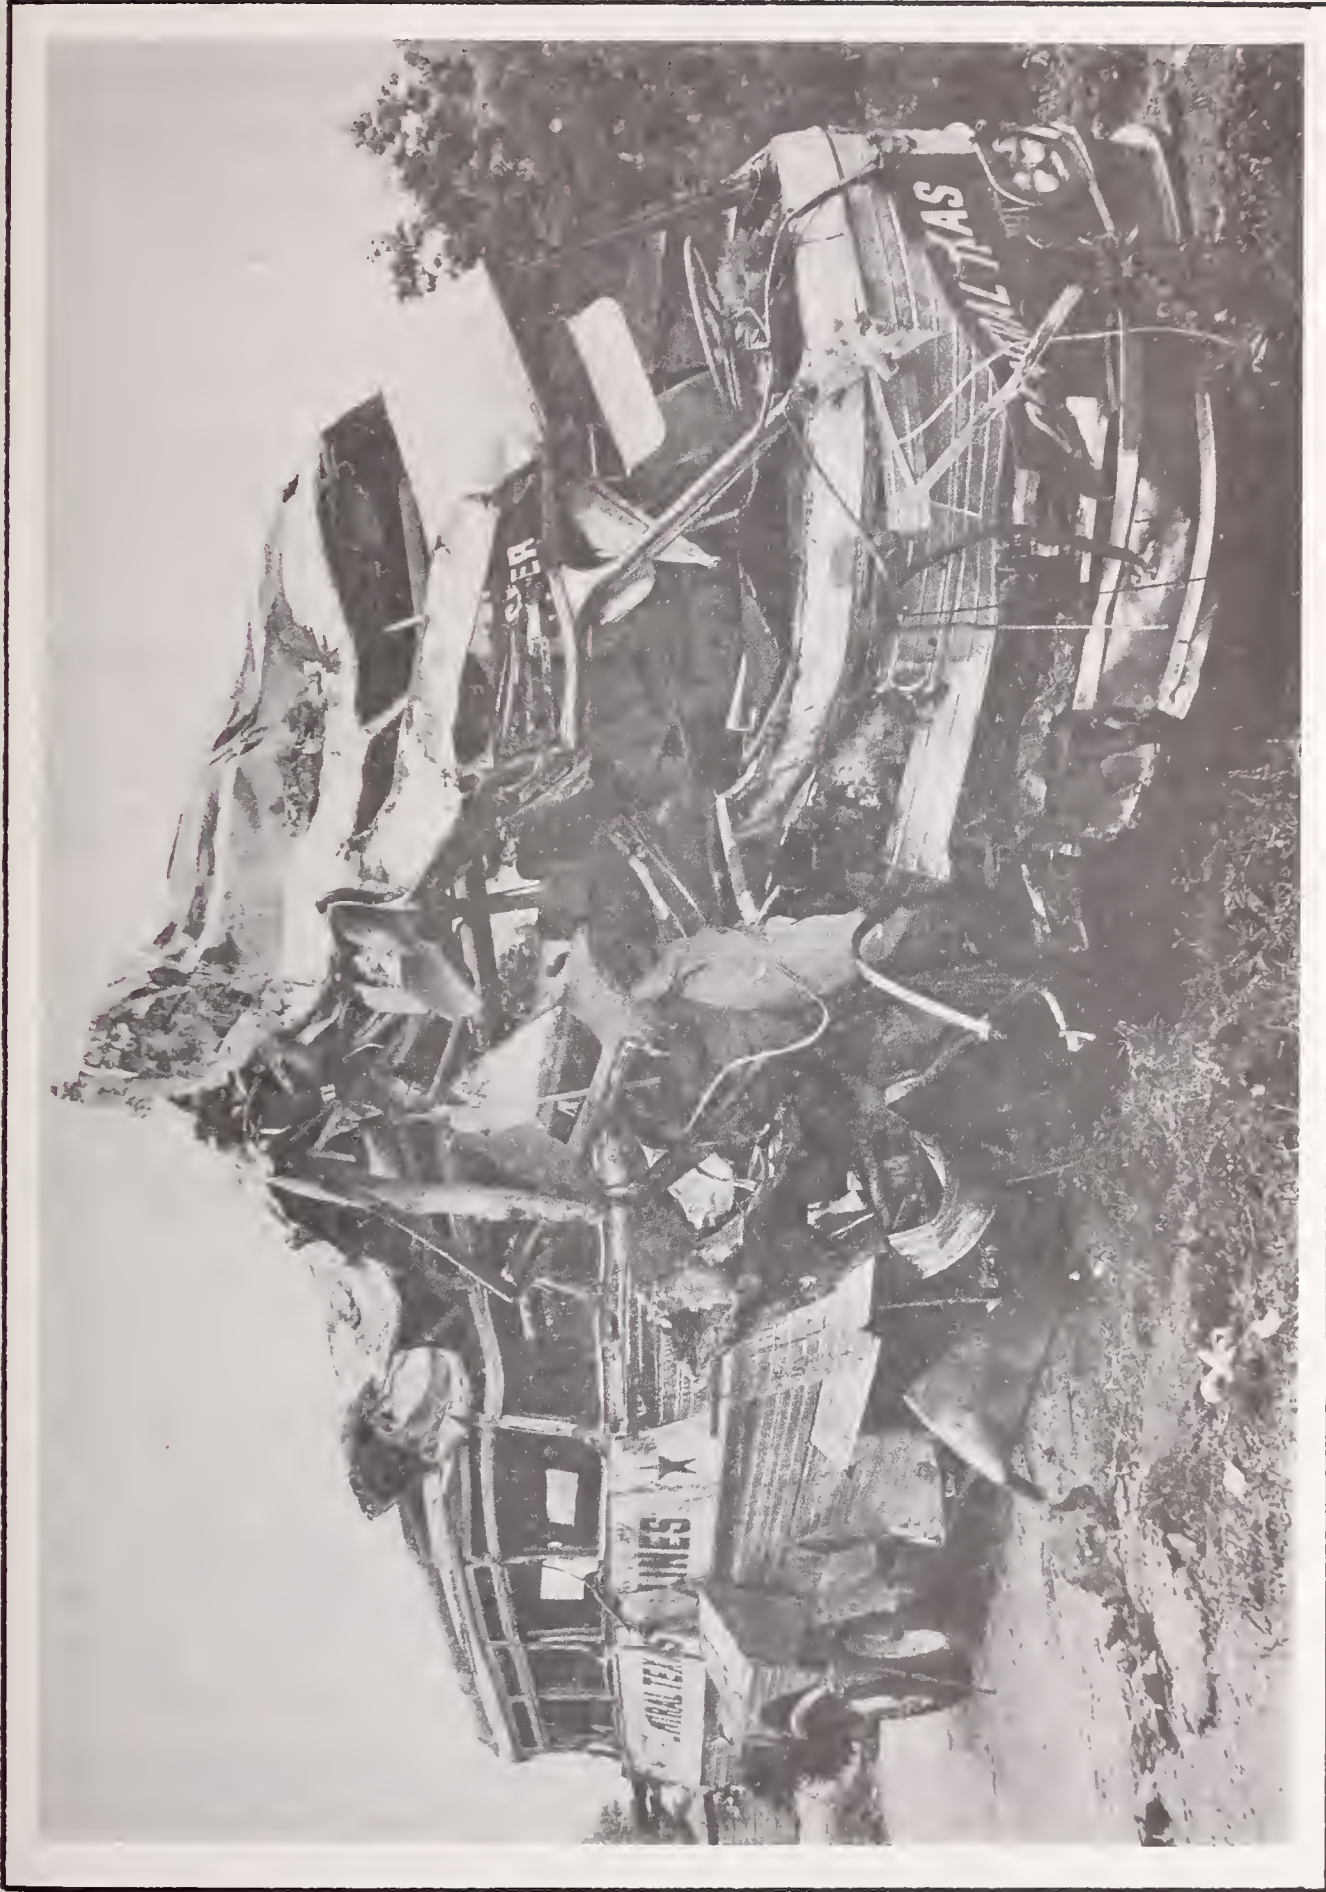
FIGURE 4-21. JASPER, ARKANSAS, INTERCITY MOTOR COACH BUS ACCIDENT:
RIGHT SIDE VEHICLE DAMAGE

The front of the bus was crushed rearward and was skewed to the right. The right front corner was crushed about 4.5 feet rearward. Several panels in the right-front area and both windshields were missing. As shown in Figure 4-21, the right forward roof structure was displaced about 2 feet inboard and rearward. Sheet metal along the right side of the bus buckled severely and was crushed inward. The passenger loading door was torn from its supporting structure as it was twisted rearward. All right side windows were missing, and the window pillars were displaced inward. The roof buckled inward as much as 2 feet in some places. Body structural members were forced rearward and contacted the outside tire of the right drive axle. The rear window was missing, and its frame was distorted.

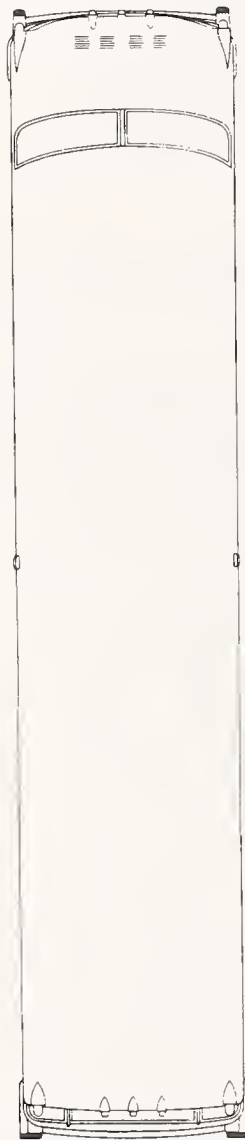
MCI Model MC-7

BATTERIES
24 VOLTS

FUEL TANK FILL

PASSENGER DOOR
RELEASE BUTTON

FIGURE 4-23. INSTRUCTIONS FOR RESCUE FORCES: GAINING ACCESS TO AN INTERCITY MOTOR COACH, OPENING THE EXIT POINTS, AND SHUTTING DOWN THE ENGINES (Continued)

A highly successful program of public information and education on rescue from intercity motor coaches is being conducted by Capitol Trailways of Pennsylvania. They have written a handout explaining how rescuers can enter their vehicles, make use of the various egress points, and shut down the engine by throwing a cut-off or battery switch or by cutting the battery cables. The handout is reproduced as Figure 4-23. Upon request, Capitol Trailways will go to any location within their service area and provide a training session to the local fire company, rescue force, and emergency medical personnel. A bus is brought to the site and used for demonstration. Participants are given experience with the vehicle and are provided with the handout. The author participated in one of these sessions and considered it very effective. It is strongly recommended that this type of program be instituted across the country.

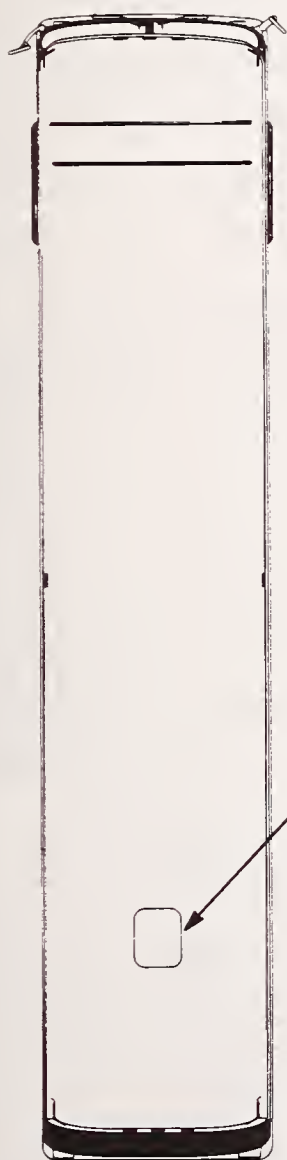
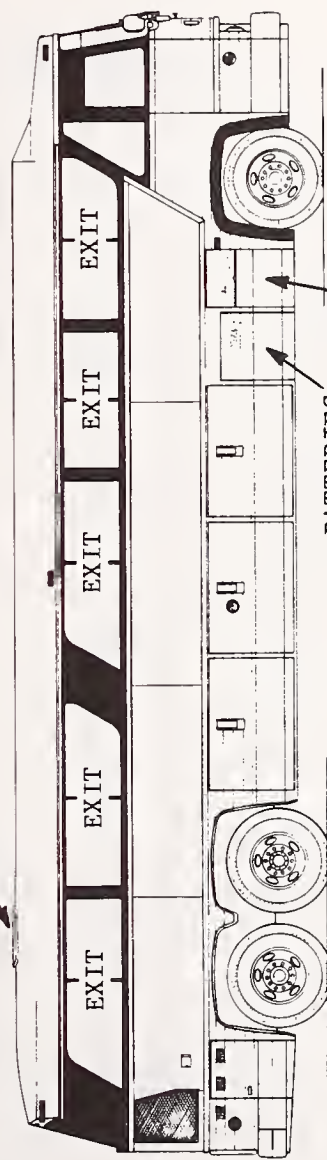
MCI Model MC-8

ESCAPE HATCH

BATTERIES
24 VOLTS

FUEL
TANK FILL

PASSENGER DOOR
RELEASE BUTTON

NOT
AN
EXIT

FIGURE 4-23. INSTRUCTIONS FOR RESCUE FORCES: GAINING ACCESS TO AN INTERCITY MOTOR COACH, OPENING THE EXIT POINTS, AND SHUTTING DOWN THE ENGINES (Continued)
